**Flood Control Project Maintenance  
Levee Inspections**

## Maintenance Issue Types Only, Levee Inspection Report By Mile - Spring 2018

### Reclamation District No. 2104 Peters Pocket Tract

Waterway	Bank	Unit Miles	Inspection Start/End	Inspector
Unit No. 01 Cache Slough/Unit No. 02 Haas Slough	Left	6.85	03/20/2018 03/20/2018	Keith Millard

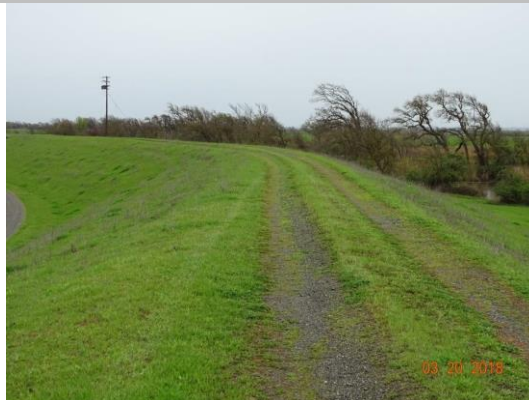
Photo 1 of 1 : SP\_2018\_RD2104\_249\_18\_20180321\_00037.jpg

LM Start	0.02	Rating **	A/W	Issue No.	18
LM End	1.45	Issue Type +	Ma	Location *	CR
Category	Earthen Levee			GPS Latitude/Longitude	
				Start	End
Item	Vegetation			38.308053 °	38.295298 °
				-121.758557 °	-121.741413 °
DWR ID	DWR_RD2104_01_f_2016_18				
Comment Code					
V9 : Keep the crown roadway free of vegetation.					
Inspector Comment

Spring 2018 - Crown road should be kept free of vegetation.

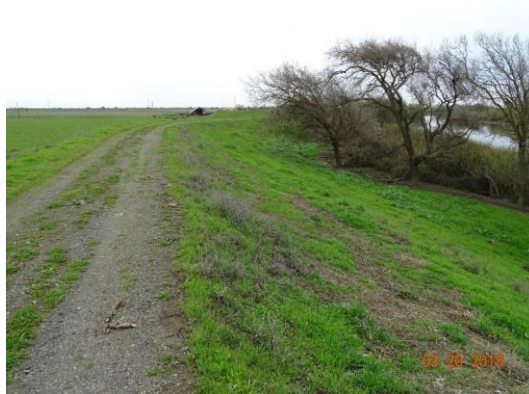
Photo 1 of 1 : SP\_2018\_RD2104\_249\_22\_20180321\_00038.jpg

LM Start	1.20	Rating **	A/W	Issue No.	22
LM End	1.20	Issue Type +	Ma	Location *	WS
Category	Earthen Levee			GPS Latitude/Longitude	
				Start	End
Item	Erosion / Bank Caving			38.296615 °	38.296615 °
				-121.745372 °	-121.745372 °
DWR ID	DWR_RD2104_01_f_2016_22				
Comment Code					
E2 : Schedule repair of erosion site prior to the next inspection.					
Inspector Comment					
Soil was added to restore waterside slope. Continue to monitor for erosion from cattle.

This previous erosion site should be monitored for future erosion from cattle.

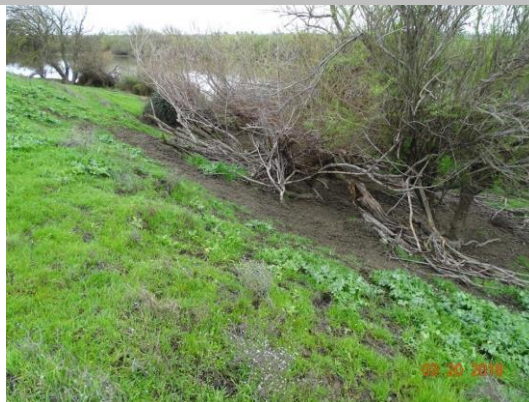
Photo 1 of 1 : SP\_2018\_RD2104\_249\_23\_20180321\_00039.jpg

LM Start	1.27	Rating **	M	Issue No.	23
LM End	1.27	Issue Type +	Ma	Location *	WS
Category	Earthen Levee			GPS Latitude/Longitude	
				Start	End
Item	Slope Stability			38.296182 °	38.296182 °
				-121.744318 °	-121.744318 °
DWR ID	DWR_RD2104_01_f_2016_23				
Comment Code					
S2 : Repair the levee slope damaged by foot traffic and prevent access where possible.					
Inspector Comment					
Repair the slope damaged by cows and trim up the tree limbs partially blocking the erosion site.

Spring 2018 - Trees should be trimmed and deadwood removed, and erosion from cattle repaired.

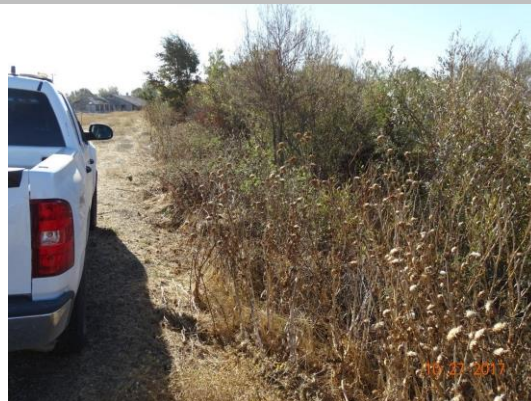
Photo 1 of 1 : SP\_2018\_RD2104\_249\_11\_20180305\_00001.jpg

LM Start	1.44	Rating **	U	Issue No.	11
LM End	1.48	Issue Type +	Ma	Location *	WS
Category	Earthen Levee			GPS Latitude/Longitude	
				Start	End
Item	Vegetation			38.295487 °	38.294947 °
				-121.741530 °	-121.741215 °
DWR ID	DWR_RD2104_01_f_2017_11				
Comment Code					
V2 : Remove the wild growth other than native grasses from the levee slopes.					
Inspector Comment

Remove wild growth to 20 feet from crown.

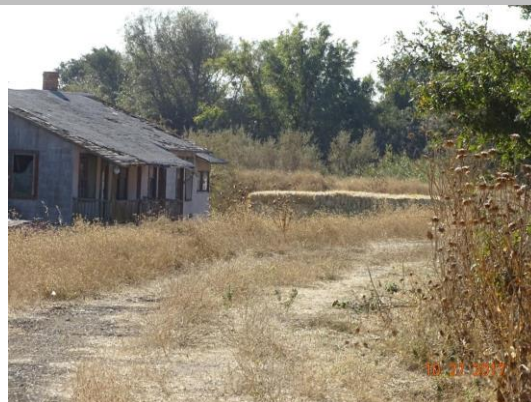
Photo 1 of 1 : SP\_2018\_RD2104\_249\_13\_20180305\_00002.jpg

LM Start	1.45	Rating **	M	Issue No.	13
LM End	4.00	Issue Type +	Ma	Location *	CR
Category	Earthen Levee			GPS Latitude/Longitude	
				Start	End
Item	Vegetation			38.295298 °	38.310680 °
				-121.741413 °	-121.736174 °
DWR ID	DWR_RD2104_01_f_2017_13				
Comment Code					
V9 : Keep the crown roadway free of vegetation.					
Inspector Comment

Crown vegetation should be reduced to facilitate inspection and access.

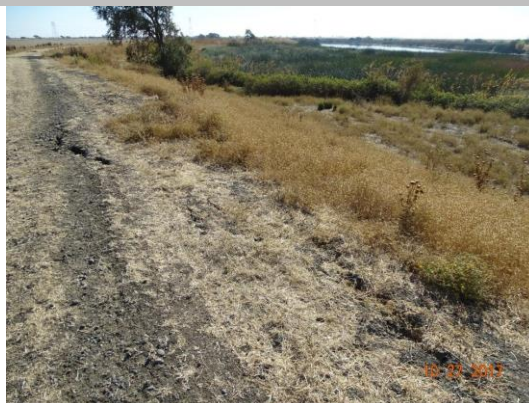
Photo 1 of 1 : SP\_2018\_RD2104\_249\_15\_20180305\_00003.jpg

LM Start	1.72	Rating **	A/W	Issue No.	15
LM End	1.72	Issue Type +	Ma	Location *	WS
Category	Earthen Levee			GPS Latitude/Longitude	
				Start	End
Item	Cracking			38.293465 °	38.293465 °
				-121.737778 °	-121.737778 °
DWR ID	DWR_RD2104_01_f_2017_15				
Comment Code					
CR1 : Monitor and have inspected by geotechnical engineer.					
Inspector Comment

Curved cracks in crown indicate possible slope instability on waterside slope. Cracks are 8 feet long x up to 6 inches wide x 3 feet deep. No other indications of slope instability observed. Levee toe is approx 40 feet from channel/slough edge.

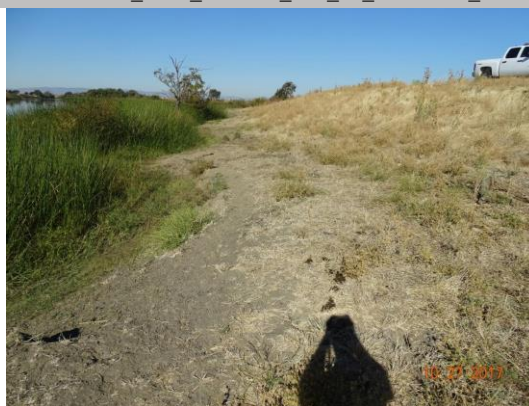
Photo 1 of 1 : SP\_2018\_RD2104\_249\_16\_20180305\_00004.jpg

LM Start	1.93	Rating **	M	Issue No.	16
LM End	1.94	Issue Type +	Ma	Location *	WS
Category	Earthen Levee			GPS Latitude/Longitude	
				Start	End
Item	Erosion / Bank Caving			38.292027 °	38.291947 °
				-121.734575 °	-121.734453 °
DWR ID	DWR_RD2104_01_s_2012_16				
Comment Code					
E1 : Note and monitor erosion site.					
Inspector Comment

Scalloped bank erosion along slough is approaching levee toe.

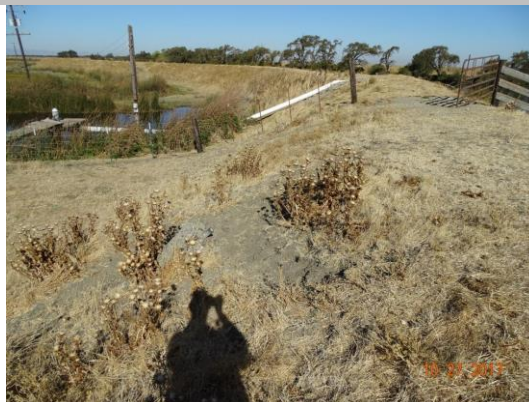
Photo 1 of 1 : SP\_2018\_RD2104\_249\_21\_20180305\_00007.jpg

LM Start	4.00	Rating **	M	Issue No.	21	
LM End	4.00	Issue Type +	Ma	Location *	LS	
Category	Earthen Levee			GPS Latitude/Longitude		
				Start		End
Item	Slope Stability			38.310672 °		38.310672 °
				-121.736155 °		-121.736155 °
DWR ID	DWR_RD2104_01_f_2017_21					
Comment Code						
S2 : Repair the levee slope damaged by foot traffic and prevent access where possible.						
Inspector Comment

Repair landside slope eroded by livestock, and prevent future erosion.

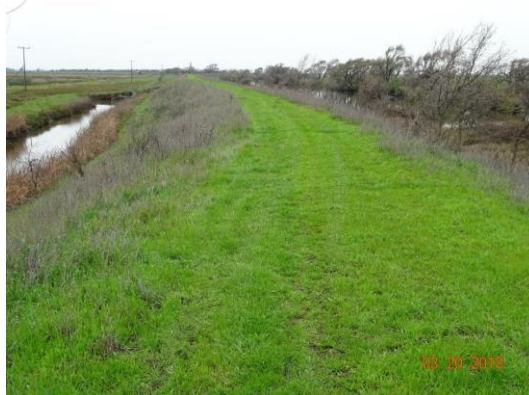
Photo 1 of 1 : SP\_2018\_RD2104\_249\_10\_20180321\_00040.jpg

LM Start	4.24	Rating **	M	Issue No.	10
LM End	4.72	Issue Type +	Ma	Location *	LS
Category	Earthen Levee			GPS Latitude/Longitude	
				Start	End
Item	Vegetation			38.313124 °	38.318437 °
				-121.739072 °	121.744572 °
DWR ID	DWR_RD2104_01_s_2018_10				
Comment Code					
V2 : Remove the wild growth other than native grasses from the levee slopes.					
Inspector Comment

Landside (left) vegetation should be managed to allow inspection and access to slope and toe.

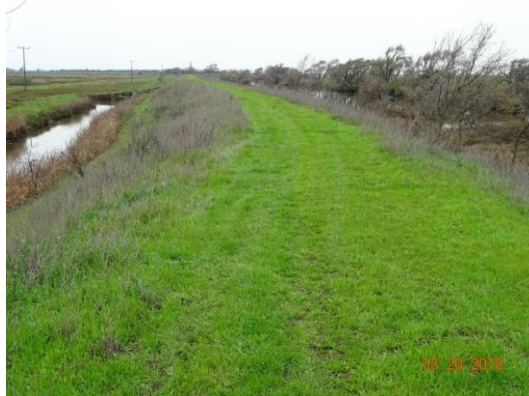
Photo 1 of 1 : SP\_2018\_RD2104\_249\_17\_20180321\_00041.jpg

LM Start	4.24	Rating **	M	Issue No.	17
LM End	4.72	Issue Type +	Ma	Location *	WS
Category	Earthen Levee			GPS Latitude/Longitude	
				Start	End
Item	Vegetation			38.313124 °	38.318437 °
				-121.739072 °	121.744572 °
DWR ID	DWR_RD2104_01_s_2018_17				
Comment Code					
V2 : Remove the wild growth other than native grasses from the levee slopes.					
Inspector Comment

Waterside (right) vegetation should be managed to 20 feet from crown to allow inspection and access.

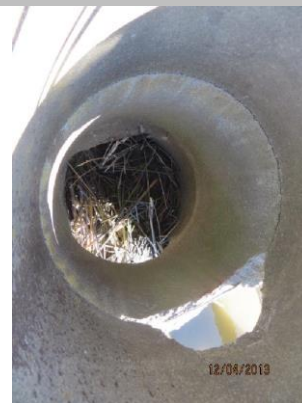
Photo 3 of 3 : UCIP\_SP\_2018\_51459\_45060.jpg

Comment Code						
Inspector Comment						
FS_ID:51459 DS_ID:24705 EP_NO: 10182 Repair Type: Non-Urgent Crossing Status: Found UCIP Comments: 12/06/2016 Crossing has been downgraded from "Urgent" to "Non-Urgent" no signs of leaks observed along pipe alignment (limited inspection on WS toe). According to LMA representative, this crossing was replaced 6 years ago (2010) at WS concrete apron. Recommend conducting internal inspection of pipe through the levee and LS to determine pipe integrity. (O. Magana - DWR UCIP)12/04/2013 Vegetation and soil buildup throughout pipe preventing flapgate from closing. Remove vegetation to allow gate to close properly. (W. Wylie - DWR UCIP) FIELD_STRUCT_DESC: 24-inch corrugated metal drainage pipe through the levee, 15 feet below the crown. 36-inch concrete standpipe on the landside (LS) toe. Flap gate on the waterside (WS) toe. Two corrugated metal cutoff walls installed. (24-inch pipe [HLM 4.65] authorized under Automatic Board Order (ABO) issued as Permit No. 10182, 1974 - Julia Trust Machado). [Additional Reference(s): DWR Levee Log, 2006. USACE Sacramento O&M Manual 108, April 1964, (HLM 4.65), Drawing No. 50-04-3379]. FS Date: 12/6/2016

36-inch concrete riser with vegetation buildup inside.

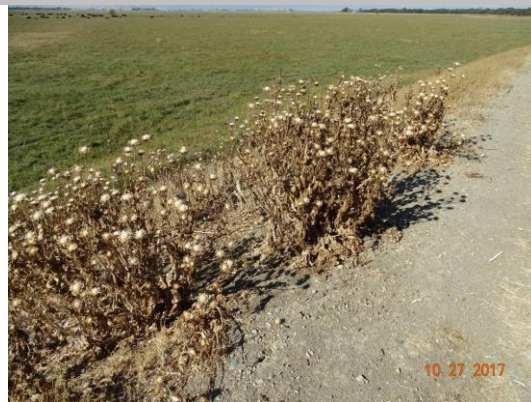
Photo 1 of 1 : SP\_2018\_RD2104\_249\_24\_20180305\_00010.jpg

LM Start	4.96	Rating **	U	Issue No.	24
LM End	4.96	Issue Type +	Ma	Location *	LS
Category	Earthen Levee			GPS Latitude/Longitude	
				Start	End
Item	Slope Stability			38.320382 °	38.320382 °
				-121.748155 °	-121.748155 °
DWR ID	DWR_RD2104_01_f_2017_24				
Comment Code					
S1 : Repair slope instability.					
Inspector Comment

Landside levee slope has slumped leaving a 2-foot vertical scarp at the shoulder. Site should be repaired.
